September 23, 2021

“The Industrial World Needs a Different Approach to Data for Wireless Condition Based Monitoring to Be Truly Predictive.”

Wireless Vibration Sensor Deployment Pulp & Paper - Fan Application

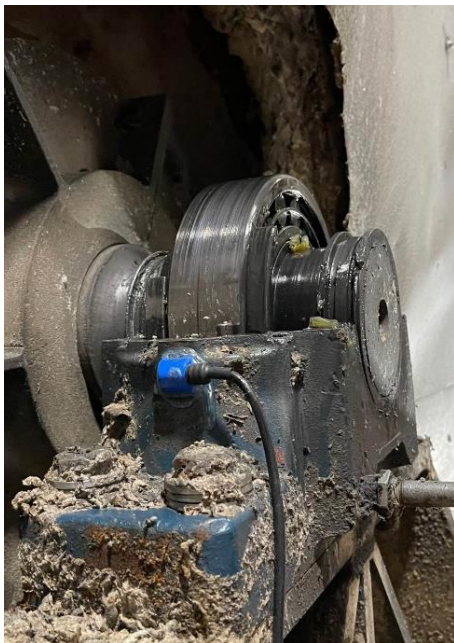
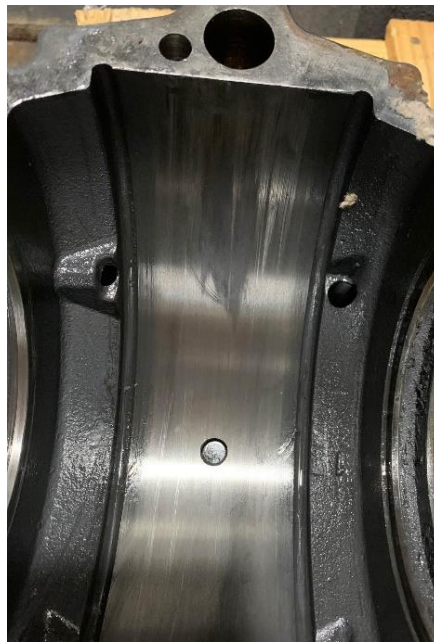
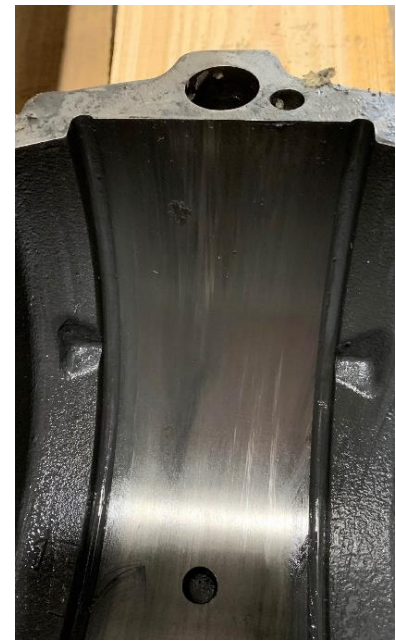
The report indicated there was looseness in the bearing due to improper clearance or fit. The mill personnel immediately made plans to remove the top of the pillow block bearing to examine and verify the findings on September 22nd. Our partner RE&E was also present to assist. Pictures of the bearings housing and outer race are shown below. The outer race as well as the bearing housing showed clear signs of rotation, verifying exactly what the report predicted.

“The picture of the bearing shows some evidence of outer race rotation. This is not good and bearing housing as well as the race needs replaced. This is the looseness that was detected on the report.”
